# HURRICANE ISABEL AND SHORE EROSION CHESAPEAKE BAY, MARYLAND

Lamere Hennessee and Jeffrey Halka  
Maryland Geological Survey

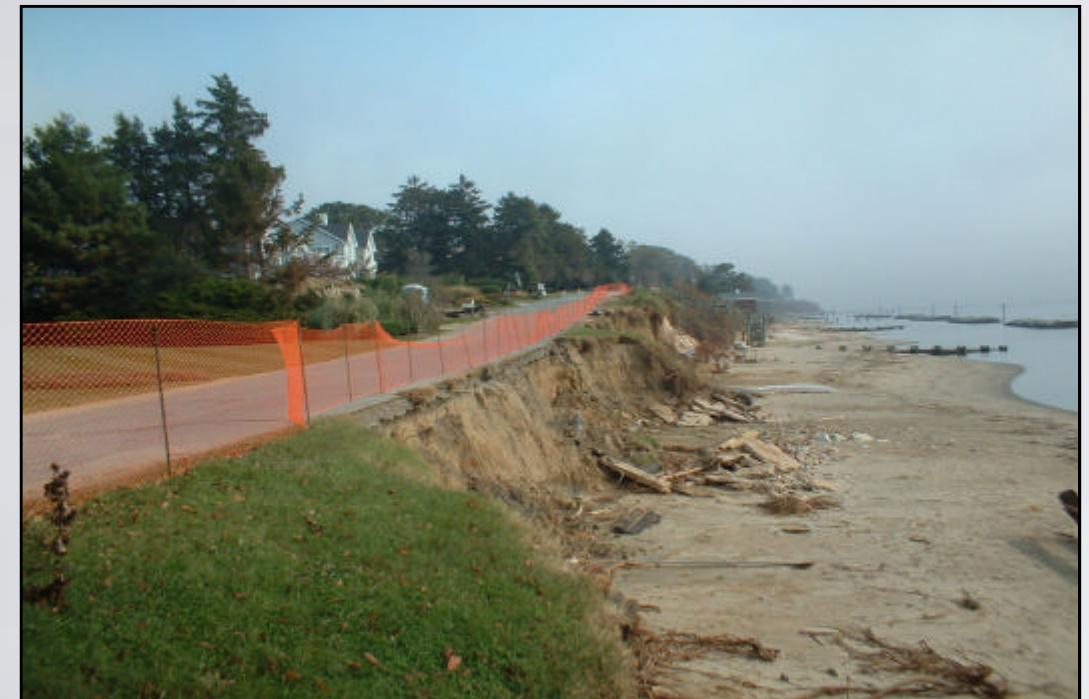
Severe erosion threatens road. Bay Ridge, Chesapeake Bay, Anne Arundel Co. [2]

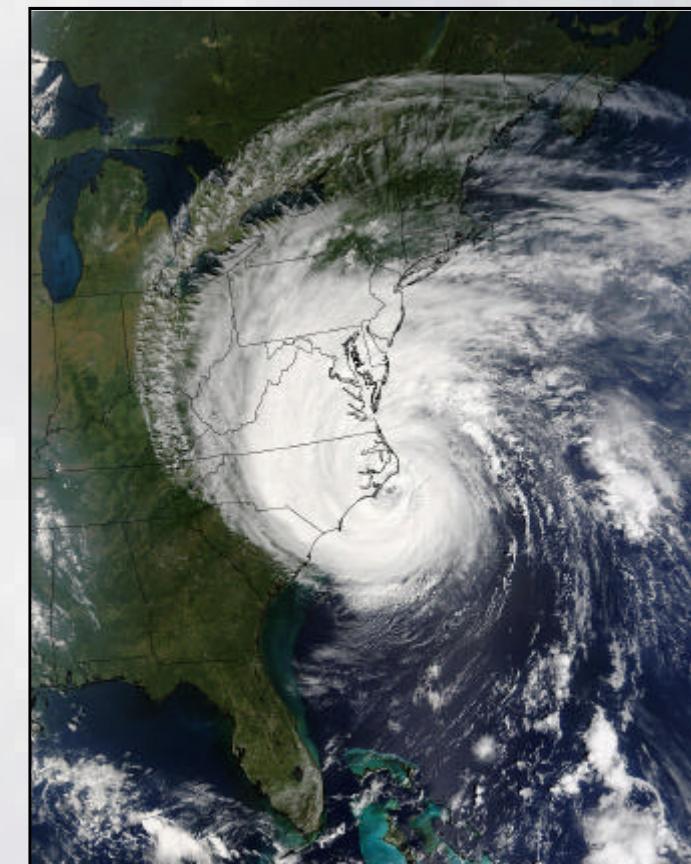
Isabel at landfall. The radius of tropical storm force winds extended 345 miles from the eye [4].

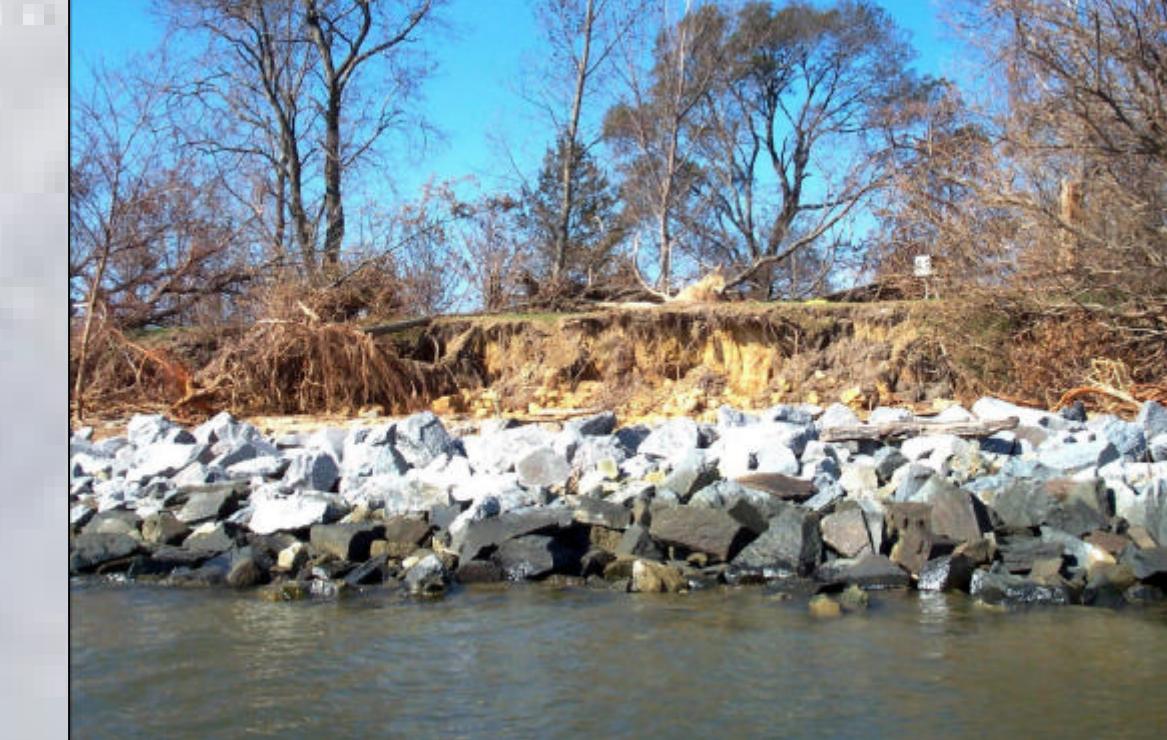
Along shorelines eroded by the action of wind-generated waves, the main effect of the storm surge was to expand the zone of wave influence, both vertically and laterally. Along high banks and bluffs, the surge elevated wind waves, extending the line of wave attack progressively higher up, and then down, the bluff face. At the base of the bluff, any protection, manmade or natural (e.g., a narrow beach at the base of the bluff), was overtapped. Laterally, the waves reached much further inland than normal. Upland reaches not usually subject to wave attack were eroded during Isabel.

Bank erosion due to vertical expansion of zone of wave influence. St. Clements I., Potomac R., St. Mary's Co. [10]

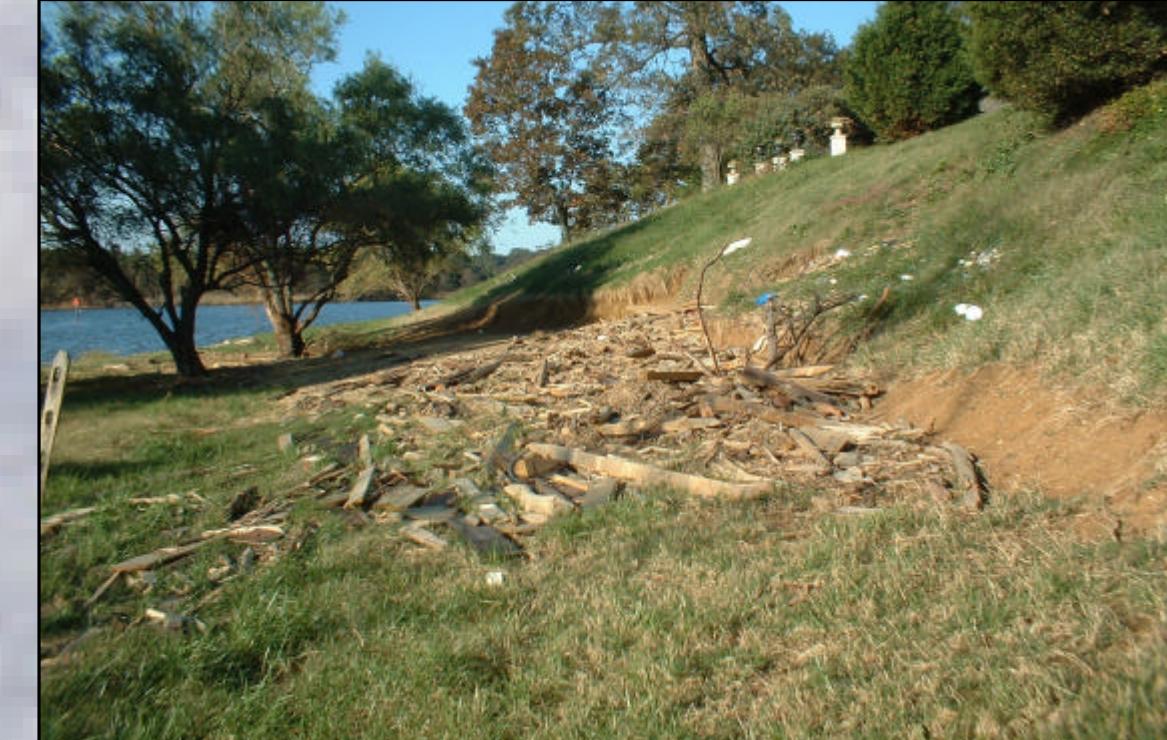
Erosion of inland bank due to lateral expansion of zone of wave influence. Anne Arundel Co. [2]

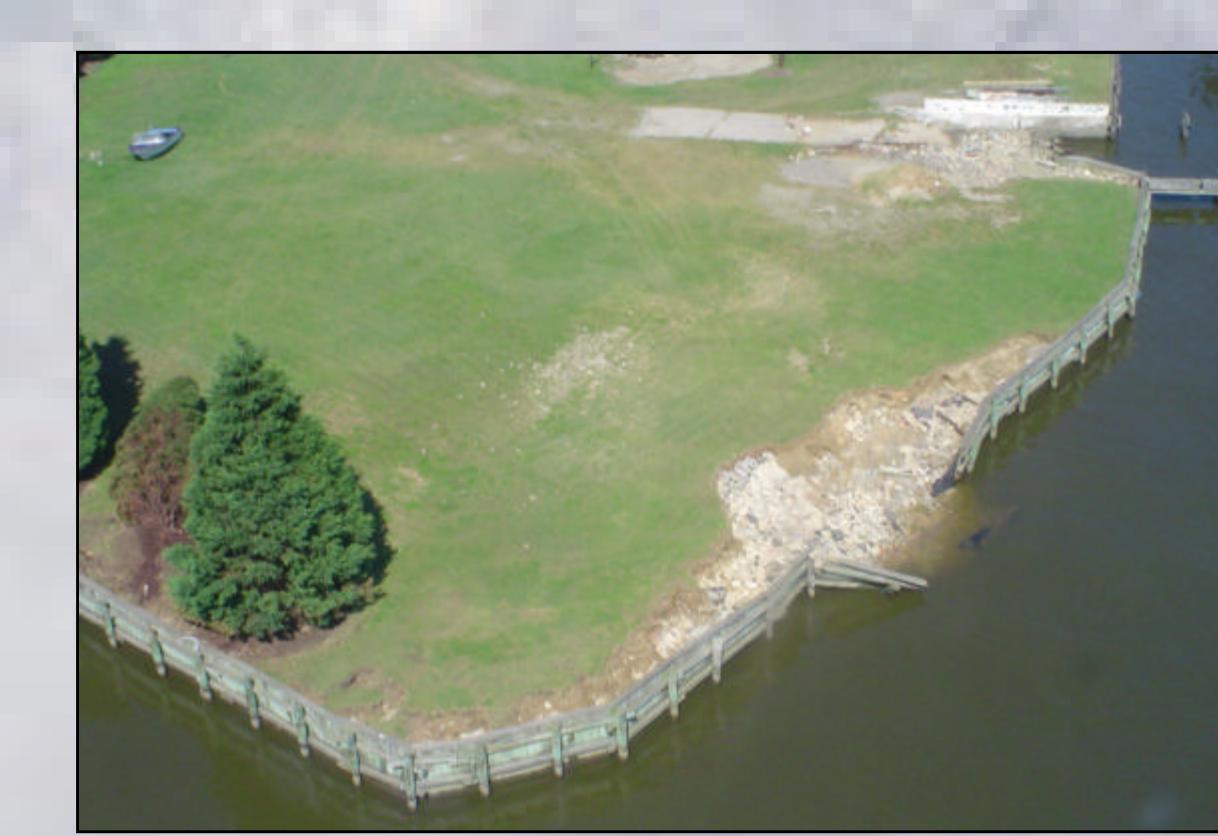
Once the storm surge had peaked, floodwaters drained back into the Bay. This storm surge ebb produced uncommon effects. Receding floodwaters scoured fastland sediment. Freestanding structures, like sheds, obstructed the ebbing flow. Along protected reaches, the ebb resulted in selective failure of erosion control structures that had been overtapped by the flood. Bulkheads and similar structures failed from behind. Once a structure was breached, water channeled through the opening, commonly scouring a semi-conic section -- wider at the top and narrower at the base -- from the exposed bank.

Bulkhead failure and fastland scour associated with storm surge ebb. Chesapeake Bay, Baltimore Co. [11].

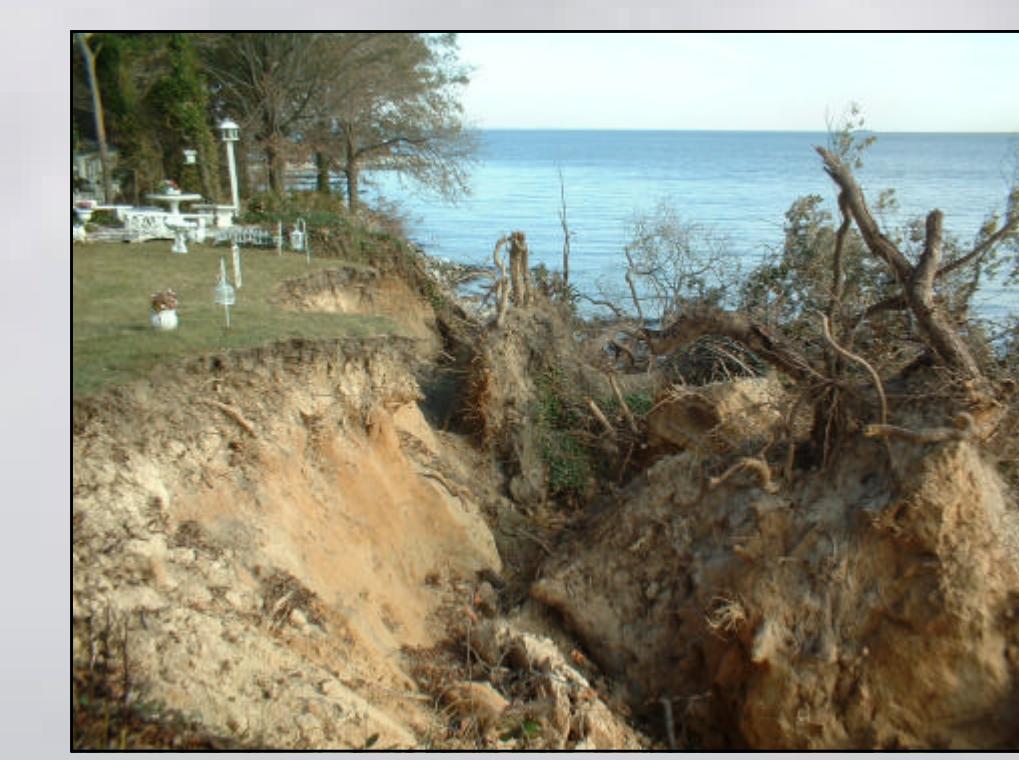
Estimated 65x25 ft section of shoreline washed away, toppling trees. Fairhaven, Chesapeake Bay, Anne Arundel Co. [2].

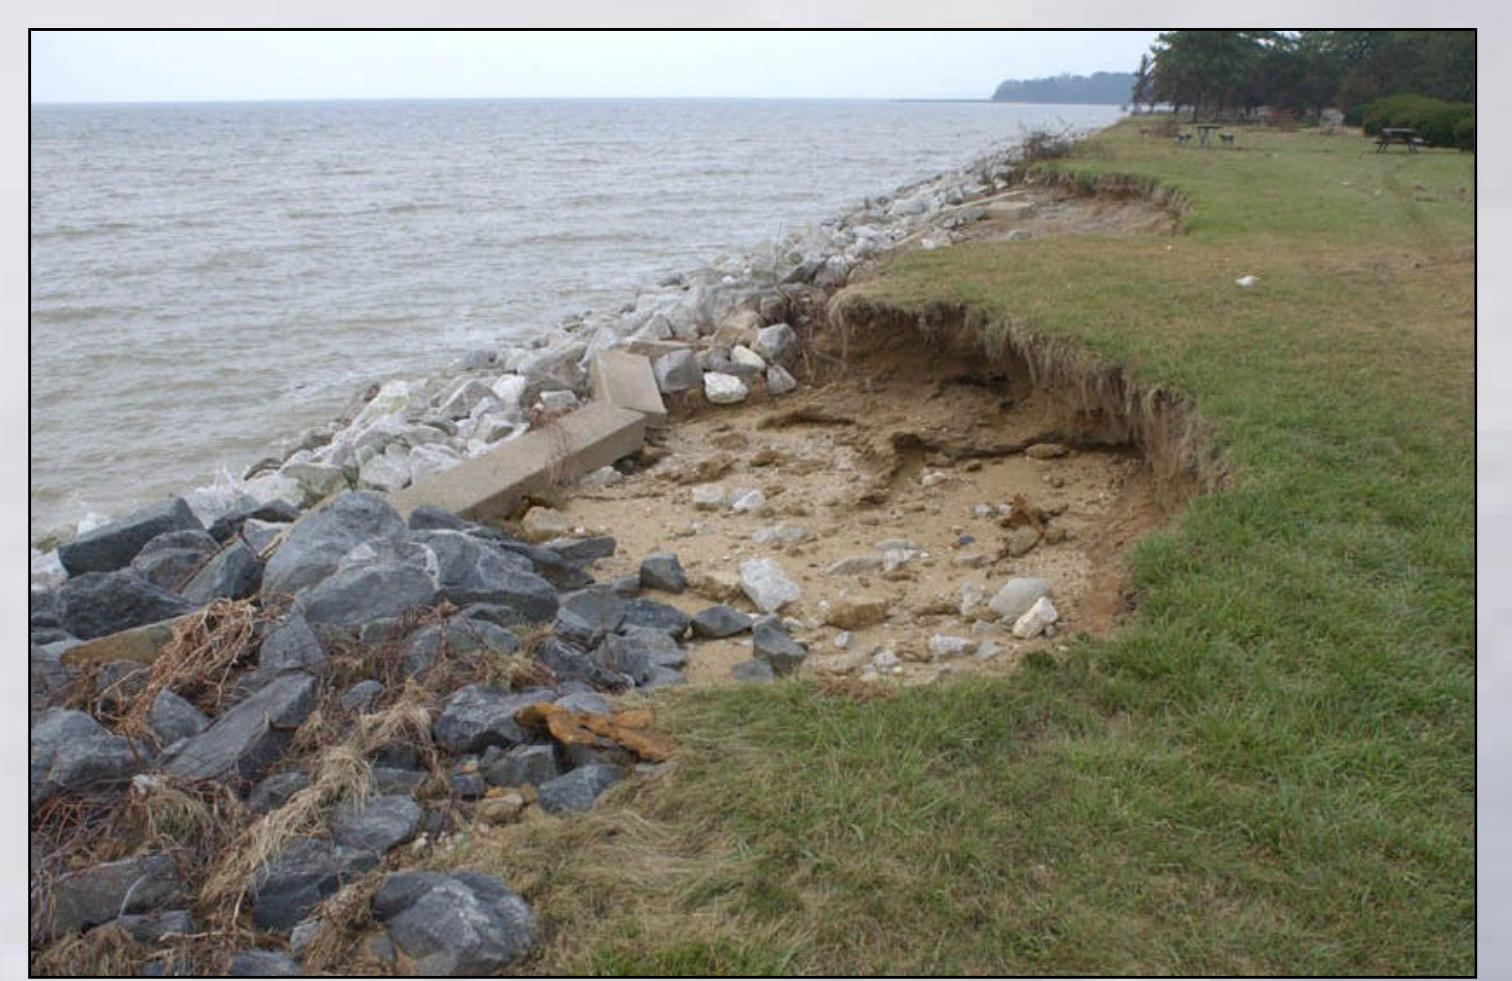
Given the elevation of the storm surge, much of the Western Shore shoreline was vulnerable to erosion. Baltimore County reissued permits for erosion control structures, primarily bulkheads, that had been damaged or destroyed by the storm. Assuming that bulkhead damage and erosion were linked, MGS mapped the sites for which those permits had been reissued. The map, biased in favor of densely developed, protected shoreline, confirms the long reach of the storm surge. Bulkheads built within the normally quiet coves of minor tributaries were damaged, as well as those lining more exposed reaches of shoreline.

Despite widespread storm surge flooding, shore erosion was irregular. Seemingly identical reaches of shoreline behaved differently. Some were unaffected. Others experienced greater or lesser sediment losses.

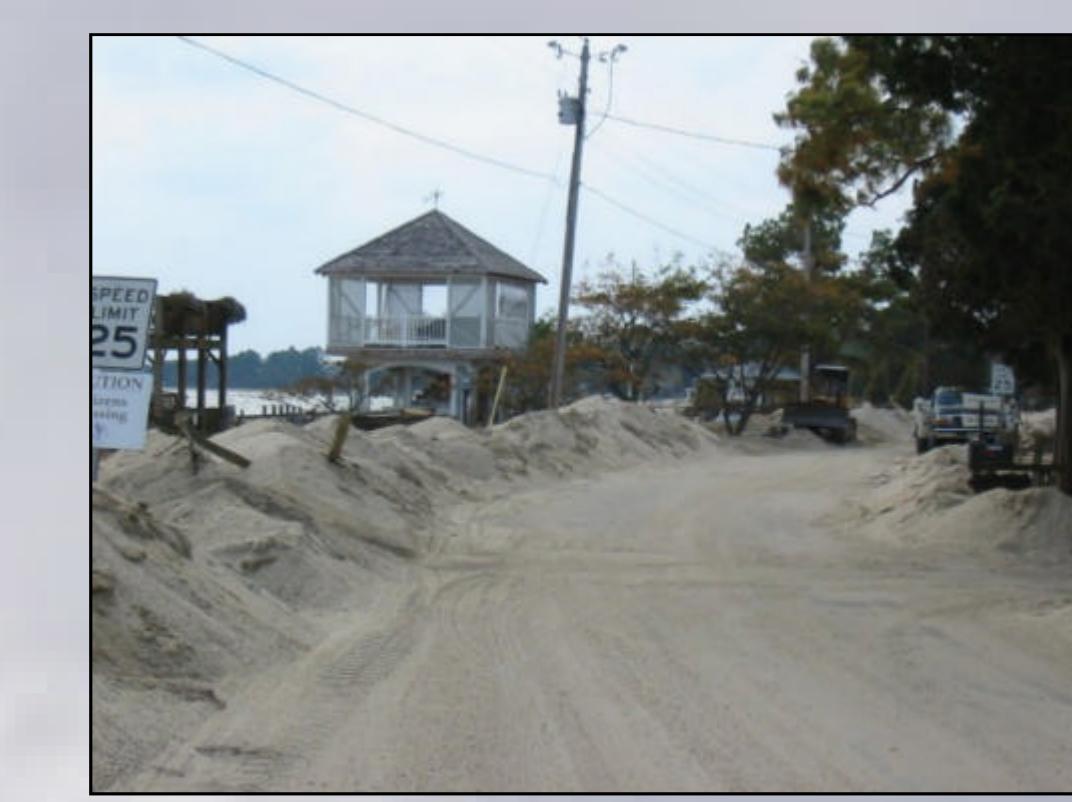
Bulldozers removed several feet of sand transported from the beach to a nearby road. Piney Pt., Potomac R., St. Mary's Co. [10].

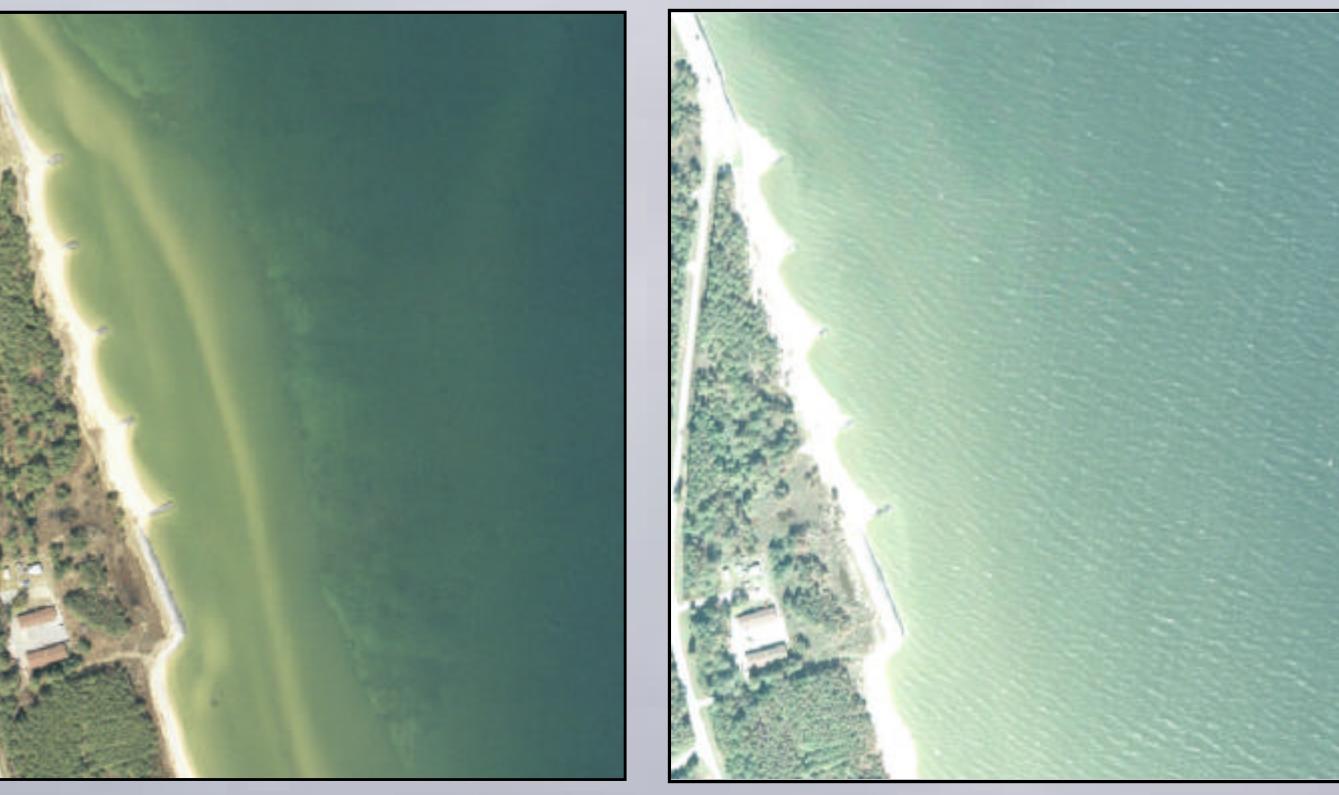
Pre- and post-storm photos showing the disruption of nearshore bars and the effectiveness of sand-trapping groins (above) and the reconfiguration of Point No Point, an incipient cuspatate foreland (below). Chesapeake Bay, St. Mary's Co. [10].

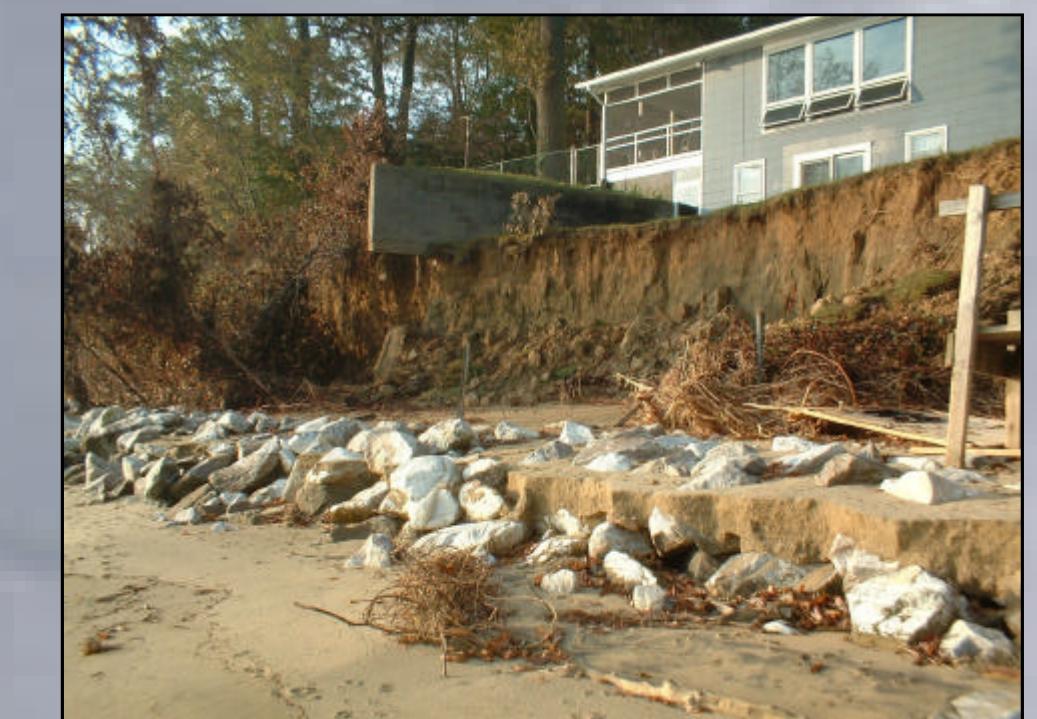
Two other variables needed to determine area and volume losses, shoreline retreat and bank height, varied widely from site to site. MGS assigned a value of 5 ft to both variables. That is, MGS assumed that along eroded reaches, a 5-ft high bank retreated 5 ft. Based on that assumption, the area of fastland eroded by Isabel equaled about 20 acres, and the volume of eroded sediment, 4.3 million ft<sup>3</sup> (122,000 m<sup>3</sup>). On average, those 20 acres, lost in a single day, account for about 15% of the acreage lost from the Western Shore in any given year.

Based in part on images like this, MGS assumed that, along eroded shorelines, a 5-ft high bank retreated 5 ft. Annapolis Roads, Chesapeake Bay, Anne Arundel Co. [2].
