FactSheet 17: Construction Information about the Sideling Hill Road Cut & Exhibit Center

Compiled from various sources by staffs of the Maryland Geological Survey and the Sideling Hill Exhibit Center.

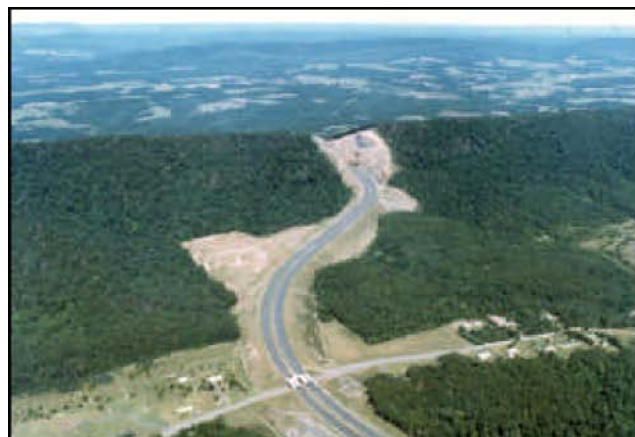
Oblique aerial view west toward the roadcut shows the ridge form of Sideling Hill before construction of the exhibit center and rest area. (Photo by Paul Breeding for the Maryland Geological Survey, 1986)

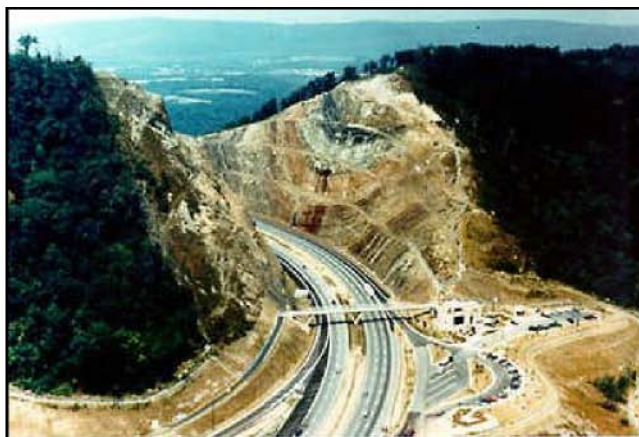
Oblique view closer to Sideling Hill than the photo at left. In this photo, the Exhibit Center and pedestrian bridge are clearly visible. (Federal Highway Administration, Maryland Division)

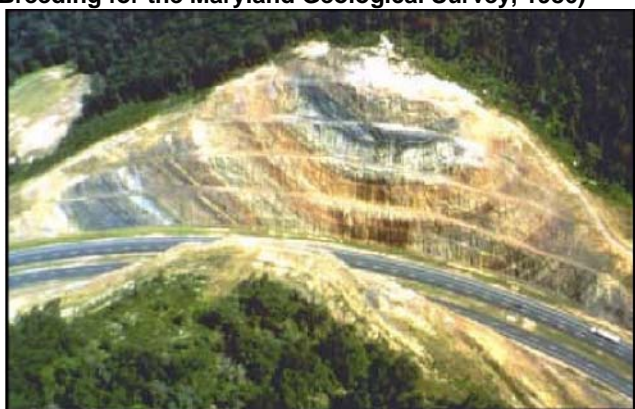
Oblique view of the north side (south-facing) side of the roadcut, showing the syncline that underlies Sideling Hill. (Photo by Paul Breeding for the Maryland Geological Survey, 1986)

The ledges, or benches, are 10 to 20 feet wide and slant towards the mountain to catch and hold falling rocks. The four ledges on each side of the cut are 80 feet apart vertically.

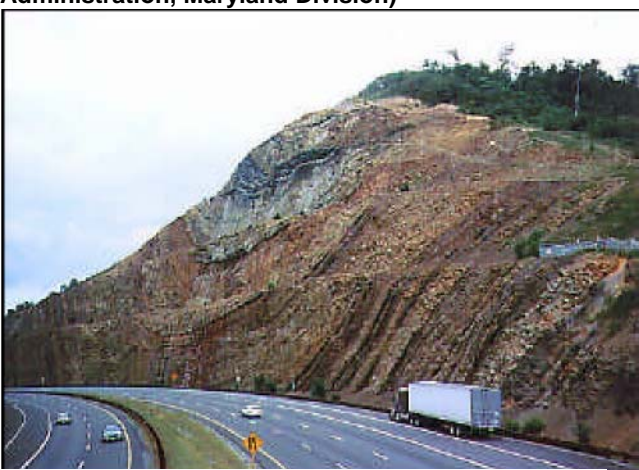
View west from the pedestrian bridge. (Maryland Geological Survey)
